August 13, 2014

Fleet Readiness Center East repairs Harrier using 3-D printing

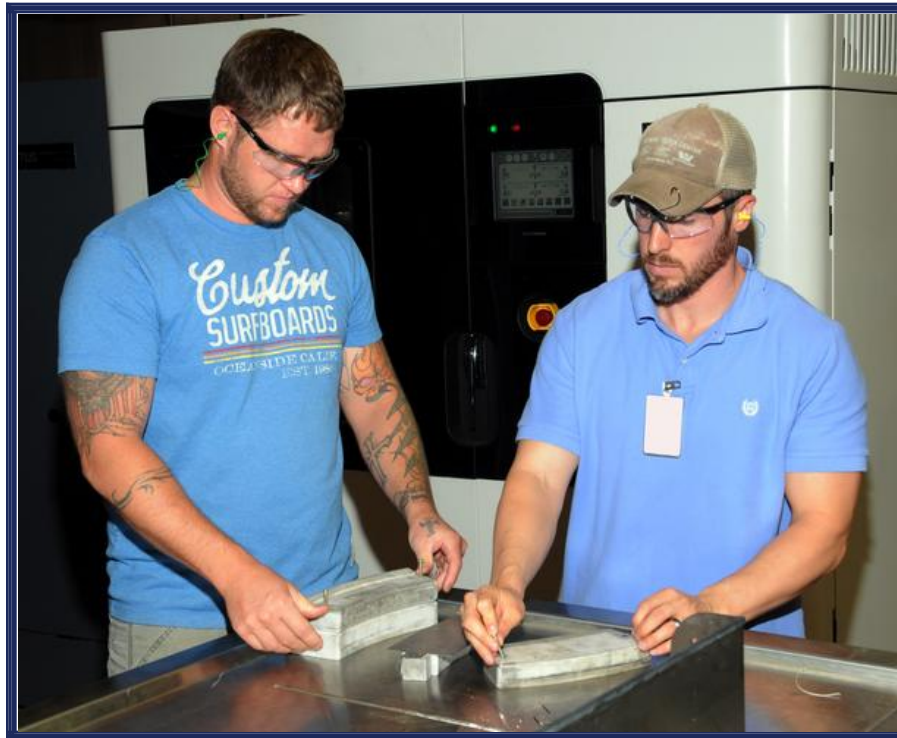
Patternmaker Caleb Guelich, left, and engineer Justin Reynolds, both of Fleet Readiness Center East, inspect polymer form blocks made through fused deposition modeling, a type of additive manufacturing, also commonly referred to as 3-D printing. The form blocks, made in a matter of hours overnight on June 26 through mid-day June 27, were used to create repair parts for an AV-8B Harrier damaged during a hard landing on the USS Bataan (LHD 5) May 28. Using conventional methods, creating these tools could have taken two to three weeks. (U.S. Navy photo)

Sheet metal forming tools and flat patterns were designed on June 25 using the Original Equipment Manufacturer (OEM) CAD model information. Within 48 hours of receipt of the OEM CAD model, tool design was complete and 3-D printing of the forming tools began.

"The tools were built using a polycarbonate material chosen because it has a high compressive strength that can withstand high-pressure presses up to 4,000 pounds per square inch (psi)," Greenwood said.

One forming tool took five hours to build, while the second set took about 30 hours.

After the AM forming tools were complete, the flat patterns were formed, using the tools, into the doubler parts on June 28. Fit-up and quality checks took place concurrently with the forming process. After forming, the parts were heat-treated and painted.
